Panasonic

WHITE PAPER INDUSTRIAL BATTERIES FOR PROFESSIONALS

LEAD ACID BATTERY CONTAINERS MADE OF ABS

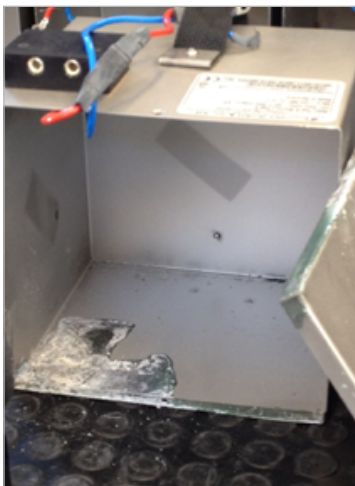
- 2) LC-XC1222P V2A box carrying case (oily residues on steel surface)

Excerpt from an analysis report where two batteries have been connected in series and installed in a box. Within less than two years of operation a crack developed and acid spilled out.

In all three portrayed cases of container leakages, it is quite likely that the combination of material fatigue and creep, plus the negative influence of ABS-sensitive substances, has caused the integrity of the container to locally collapse.

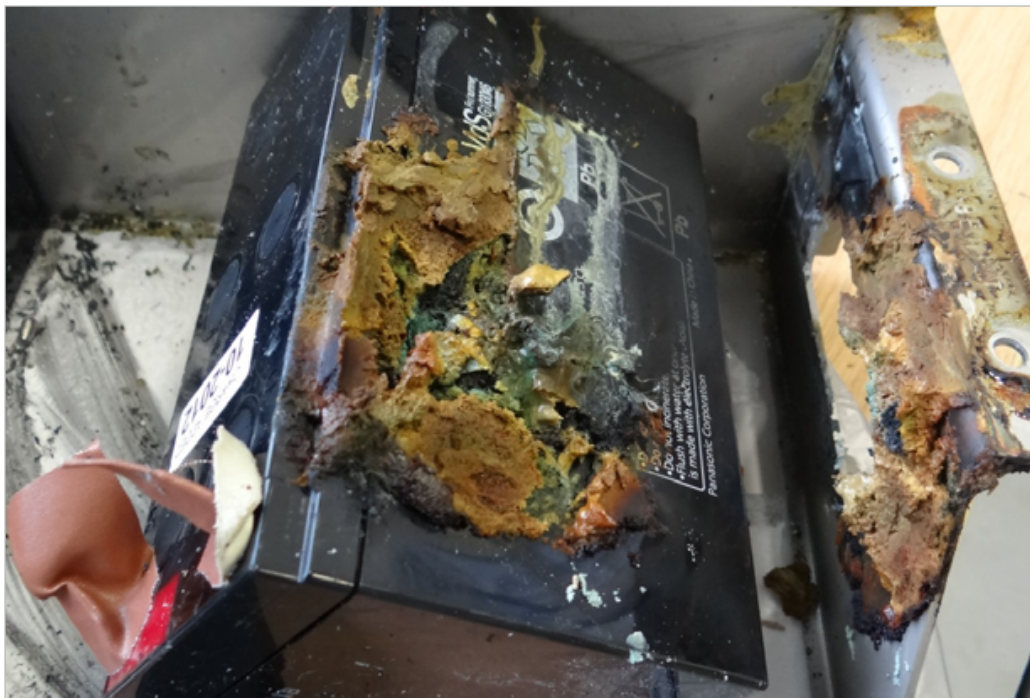
3) LC-R127R2PG1 in V2A steel case (plasticizers and fatty acid amides remnants from assembly process)

Excerpt from an analysis report where 32 batteries have been connected in series. After 3 years in operation one battery started to leak. Location was near the sidewall of the installation bracket.
